Milestone Inspection Report – Phase I

The Arlington House Building

The Berkeley House Building

The Claridge House Building

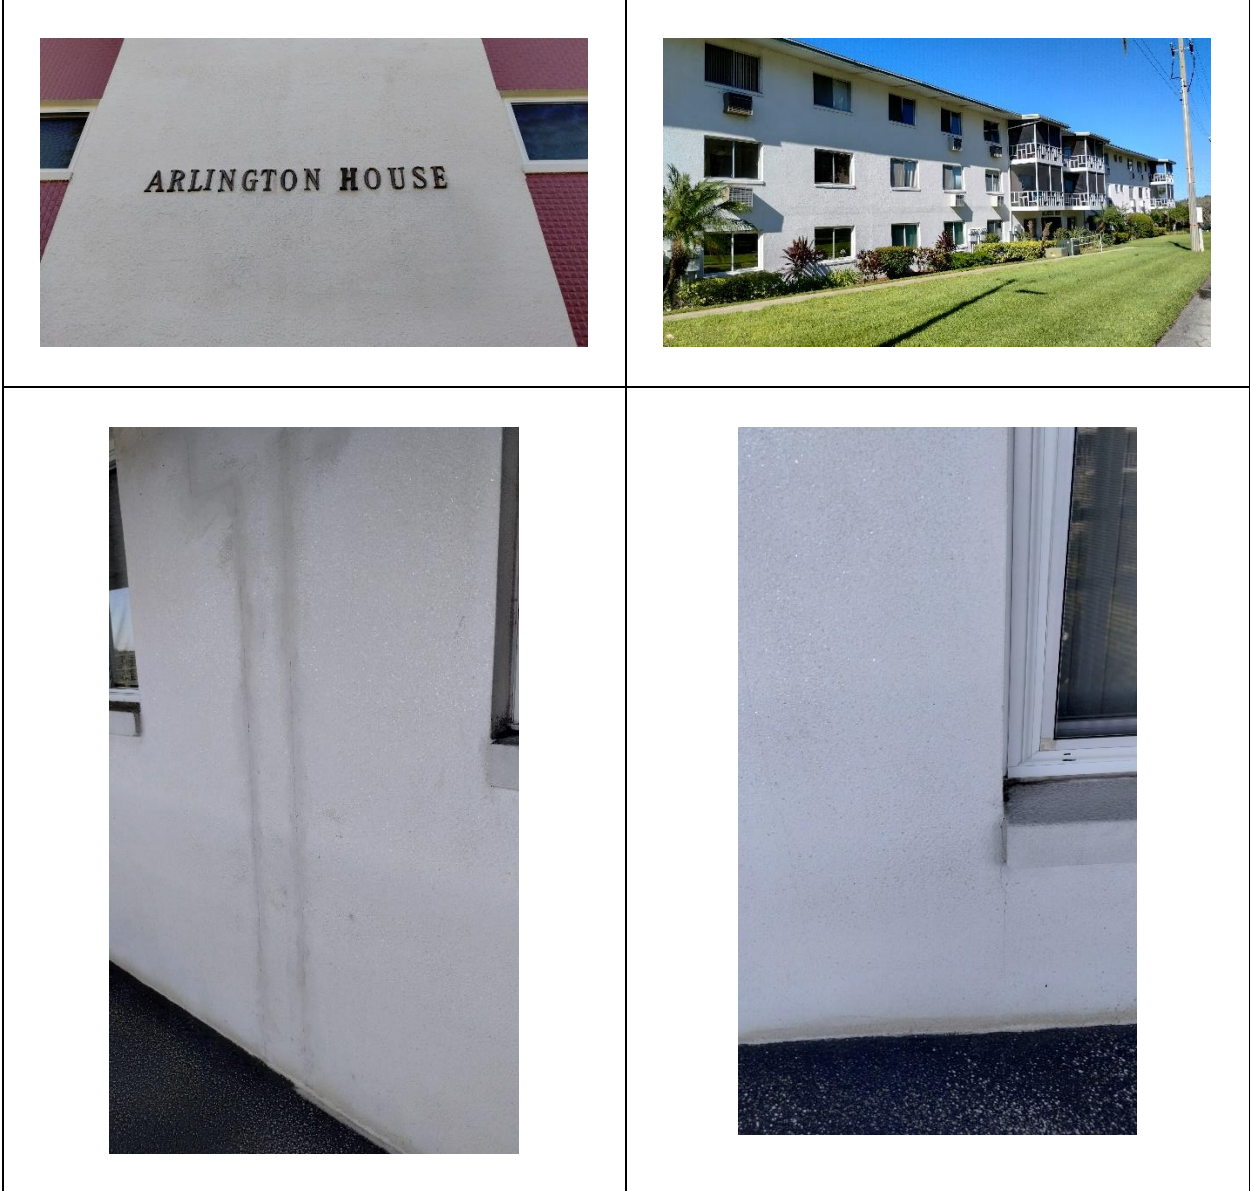
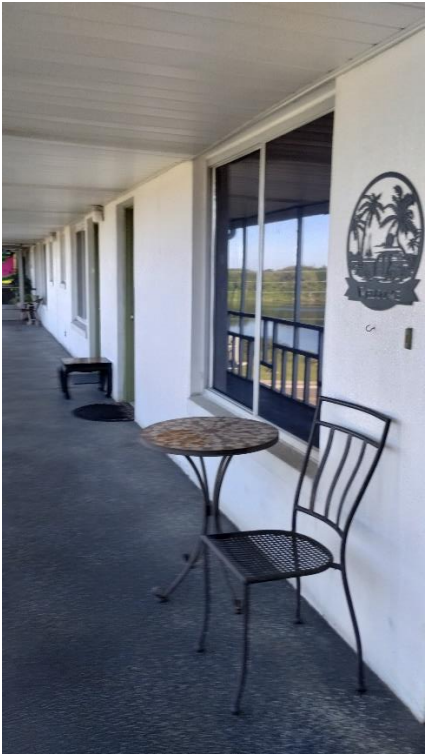
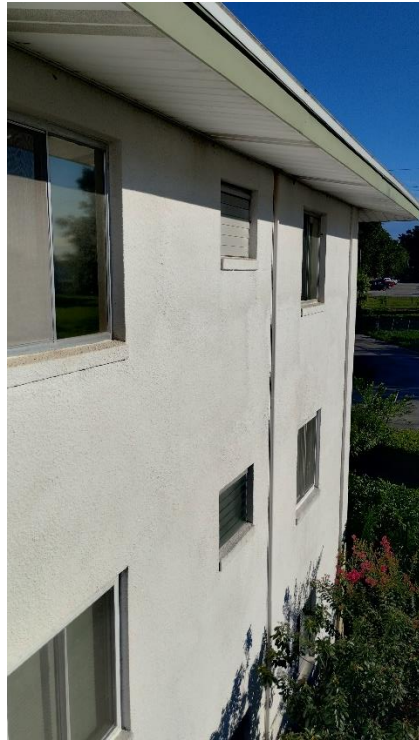
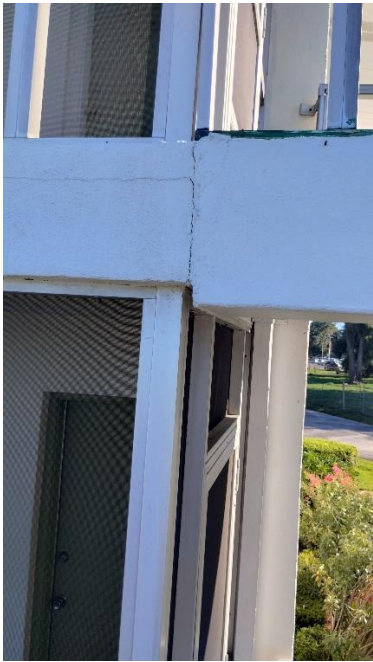
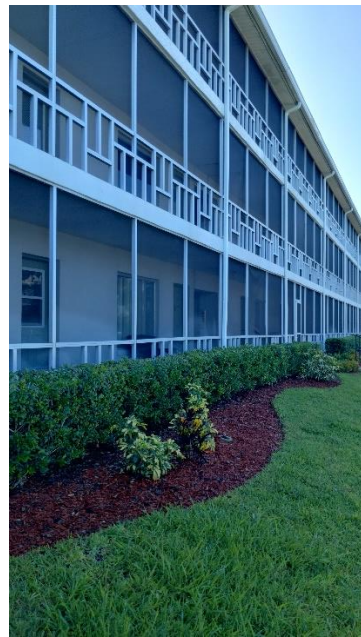
A very small area of the cinder block wall (approximately 6 inches by 6 inches) adjacent to an air conditioning unit on the first floor, north side of the building was failing. Specifically, it appears the small section of concrete was separating from the wall.

The engineer noted one small area (about 6 inches by 6 inches) of the exterior wall on the first floor, north side of the building, which was failing.

It is recommended the small area noted above be "tapped" with a hamper to remove loose concrete; rust be removed from any visible rebar; visible rebar be primed/painted; the area be filled with concrete/mortar, and the finished surface be painted.

It is recommended that any loose concrete be removed, any visible rebar be clean/painted, and the area be properly covered with concrete/mortar and be painted.

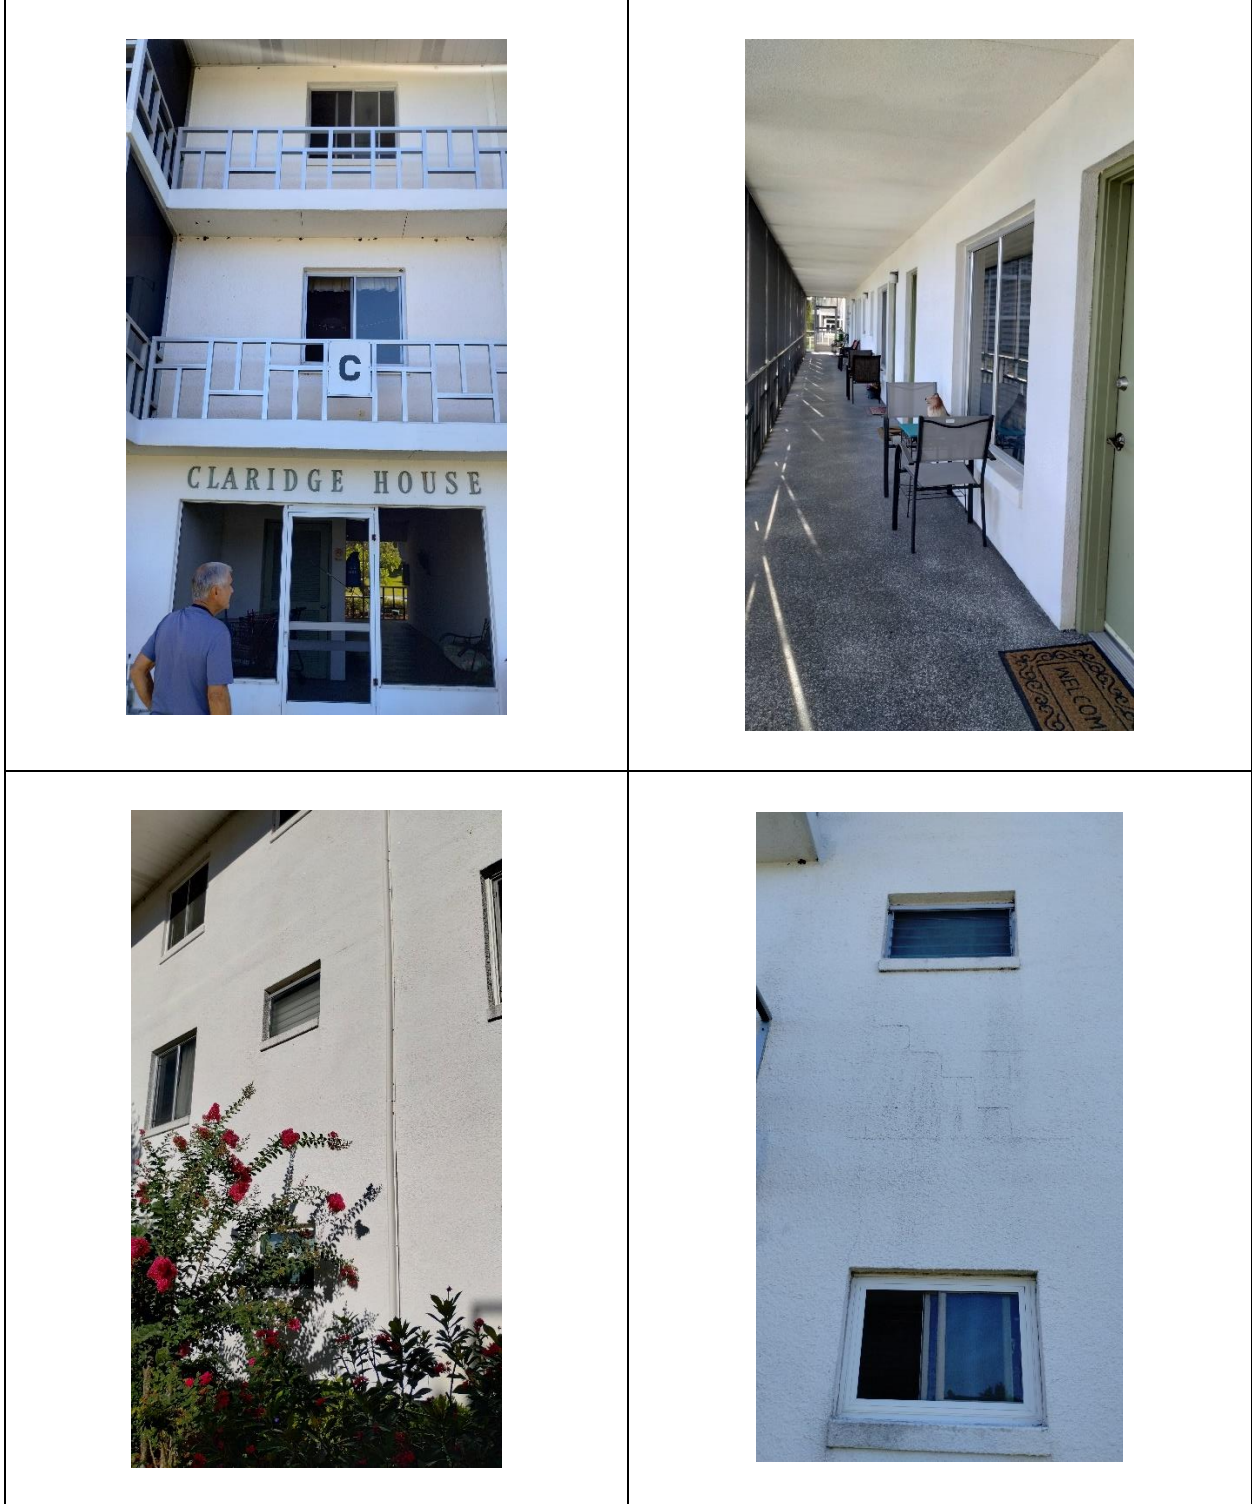
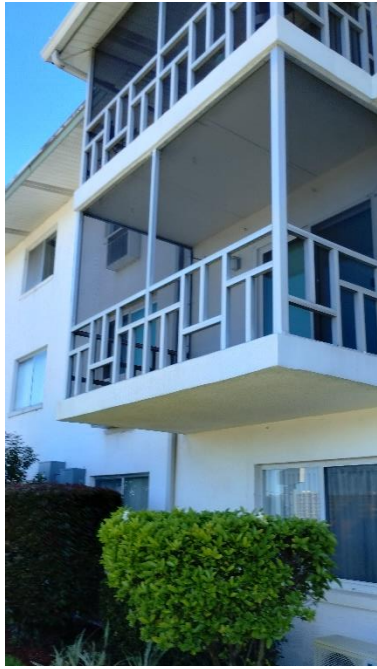
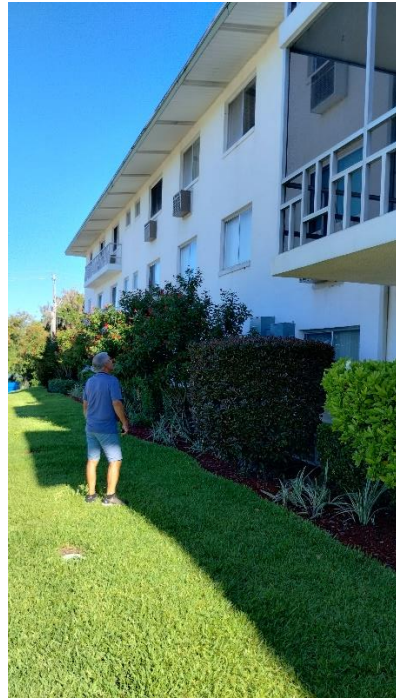
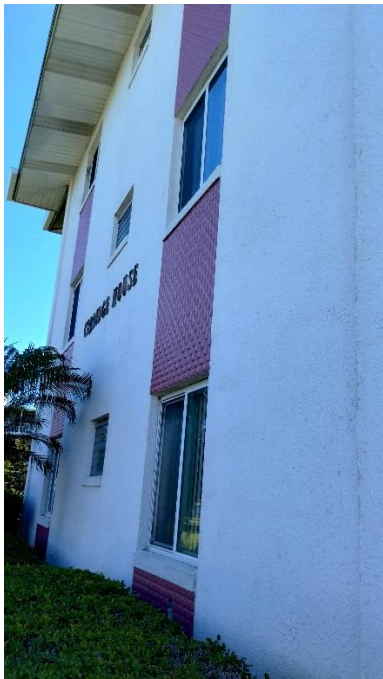
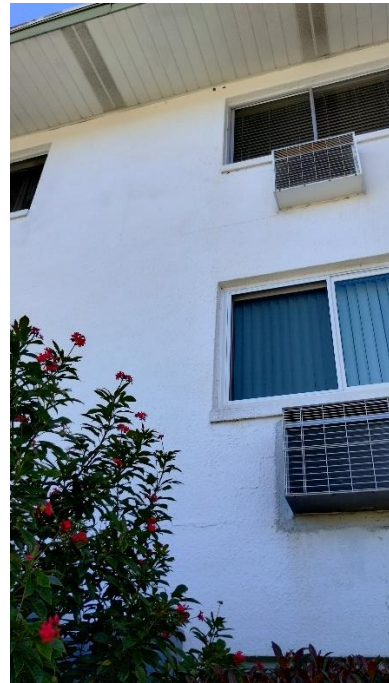
About three inches of rebar located a few inches above the ground on the south side of the building was visible.

The engineer observed about three inches of rebar located a few inches above the ground on the south side of the building.

It is recommended that all rust be removed from the visible rebar; the rebar be properly coated; the area be filled with concrete/mortar; and the area be properly painted.

It is recommended that the rebar be cleaned, painted, and properly covered with mortar.
